REPORT NUMBER: WI-07-02

DOWEL BAR RETROFIT

STH 13 CONSTRUCTION & ONE-YEAR PERFORMANCE REPORT

NOVEMBER 2002

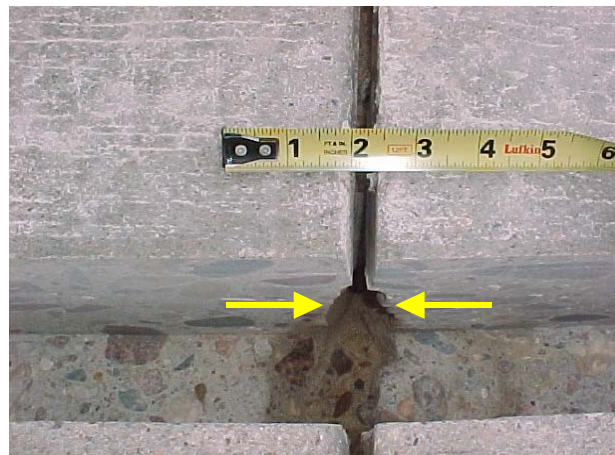
As standard practice, when STH 13 was initially constructed the transverse joints were only cut a few inches deep. The remaining concrete beneath the saw cut was left to crack on its own. The cracking of the cement paste around individual stones within the concrete creates a jagged break at the joint. At the time, it was believed that the jagged joint created from this cracking process would provide enough aggregate interlock to effectively transfer load. This assumption proved to be incorrect. Over time, the jagged edges of the slabs beneath the joint cuts wore away at each other and no longer provided enough aggregate interlock to transfer the loads effectively. The gaps between the slabs, where the aggregate and concrete have worn away, created some difficulties with dowel bar placement since it is not possible to line up a straight piece of foam board with a jagged joint (Photograph 23). This problem was evident in each test section. Caulk was used to seal these joint gaps, found at the bottom of the slot sidewalls, to prevent the mortar from entering.

Photograph 23. The concrete slabs have worn each other away beneath the joint saw cut.

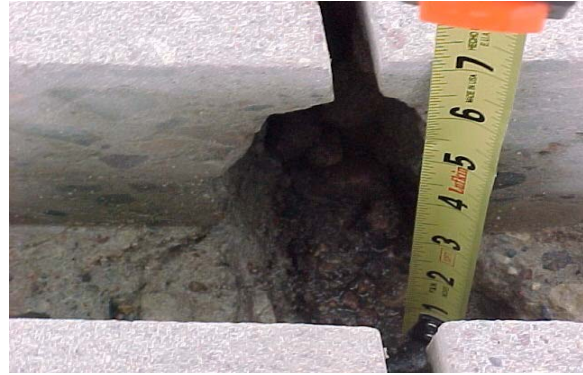
Severe deterioration of the concrete pavement at the base of the slots was also noticed in some of the slots (Photograph 24). The deterioration appeared to have occurred from the bottom up, creating big voids in the bottom of the pavement. This problem was most prevalent in areas of lower elevation, especially in the slots near the outside edge of the roadway. Initially the voids were filled with caulk but it was determined that this was not a cost-effective

Photograph 24. Bottom up deterioration of pavement is prevalent in areas of low elevation.

solution for the remaining work. Filling these voids with concrete patch material, during the fill of the slots, was not considered since that could create further problems due to point loadings during warm temperatures when the adjacent concrete slabs expand. Using a longer piece of foam board was discussed as a possible solution, but it was not tried due to a lack of extra foam board material on site. It was decided that flint silica sand be used to fill in these voids for the remaining work. Sand however, was not a very effective solution to this problem because it was easily blown out of the slot when the leaf blower was used to clean the slot directly before pouring.

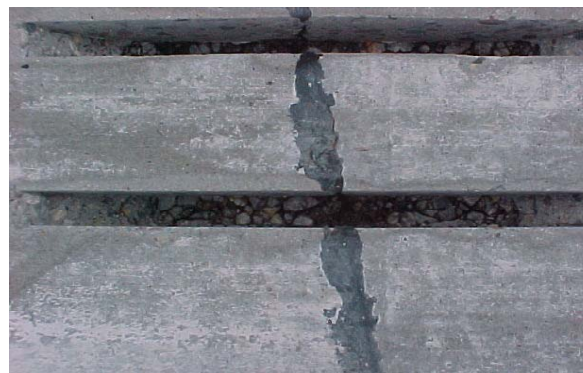
In the southbound passing lane at the intersection of STH 13 and 26th St., the cleared slots revealed the subgrade (Photograph 25). The pavement in the intersection area was found to be much thinner than the adjacent pavement, at only about 6 inches thick. For this small number of joints, the dowel bars were positioned so that the foam board held them up off of the

Photograph 25. An area of thin pavement was unexpectedly revealed when subgrade was exposed after jackhammering.

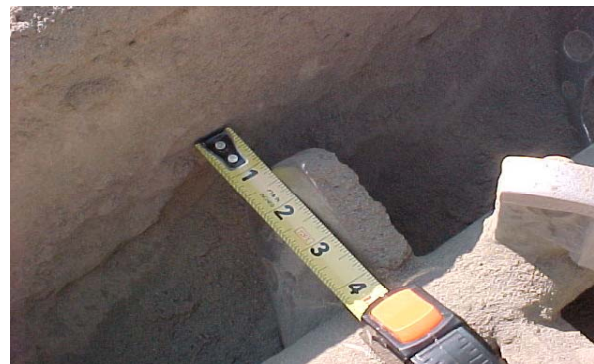
One theory is that when the sand/cement mixture reaches the mixing auger during calibration, the sand settles around the sides of the chute and only the smaller sized cement is discharged by the auger. Eventually, enough sand builds up in the chute that the mix pushed out by the auger contains a very high proportion of sand. This theory led to a second remedy to aid in calibration, which was to replace the auger flights on the mixer. The existing flights had up to a 2-inch gap between the tip of the flight and the side of the chute (Photograph 26). Upon comparing the new flights to the existing flights, it was found that there was little noticeable difference in the size. It was concluded that the condition of the auger flights was not the cause of the problem and the new flights were not installed.

Photograph 26. Some auger flights had gaps as wide as two inches between the tip of the flight and the side of the chute.

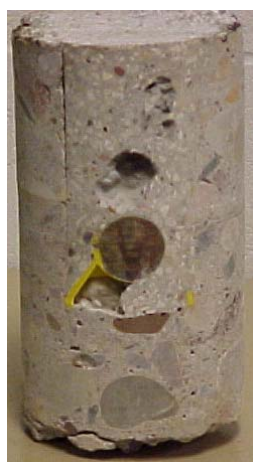
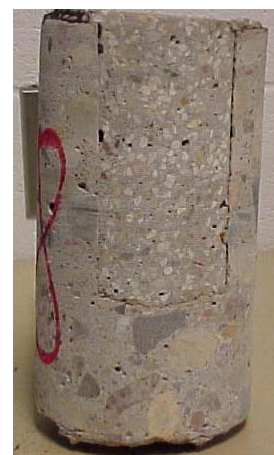
A separate patch material issue affecting the Mn/DOT Specification 3U18 Concrete Mix was discovered upon coring. Of the four cores taken of the Mn/DOT Specification 3U18 patch material, two of the cores revealed extremely poor consolidation of the patch material around the dowel bar chairs as well as poor bonding to the sidewalls of the slots (Photographs 30 and 31). The poor consolidation of the patch material is most likely due to the mix's low slump requirements. With a maximum slump allowance of only one inch, the patch material is very stiff, making it difficult to vibrate into place.

Photographs 30 and 31. The front and back sides of a Mn/DOT Specification 3U18 core show poor consolidation of the patch material as well as poor bonding to the sidewalls.

It is now believed that the main causes of the debonding that the Mn/DOT Specification 3U18 patch material is experiencing at the sidewalls are drying, plastic, and chemical shrinkage. Although it can be influenced by many factors, it is believed that the shrinkage occurring with the Mn/DOT Specification 3U18 patch material is a result of the type of cement used in the mix design. While the other mixes used in this study contain high alumina cements, the Mn/DOT Specification 3U18 mix consisted of ordinary Portland cement. As the mix undergoes shrinkage, the volume of the cementitious paste contracts as water evaporates from it and as the chemical process of hydration progresses. The effects of this volumetric change are restrained through the bond to the existing concrete and can result in cracking and debonding at the interface. In addition, tensile stresses develop in the repair material. As tensile stresses accumulate and exceed the tensile capacity of the patch material, cracking and debonding of the repair section can occur where the stress concentrations are highest or where the bond strength is weakest. It should also be noted that the Type III Portland Cement that WisDOT used in Mn/DOT's 3U18 mix has a higher shrinkage potential than Type I Portland Cement.

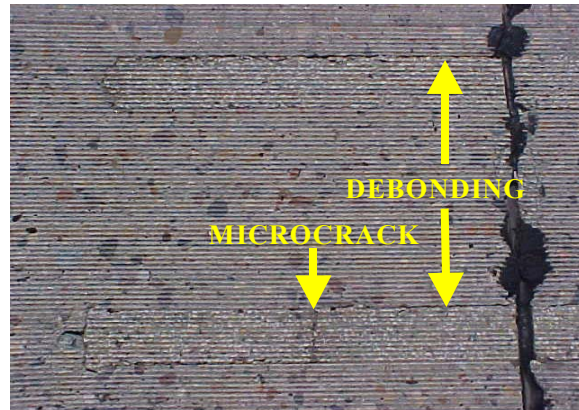
Debonding and microcracks were observed in both the Mn/DOT Specification 3U18 and Tamms Speed Crete 2028 test sections. As previously mentioned, it is believed these distresses are caused by drying, plastic, and chemical shrinkage. The Mn/DOT Specification 3U18 test sections, located in the southern half of the northbound driving lane, exhibited debonding of the patch material from the dowel bar slot sidewalls and, in some locations, from the transverse ends of the slots (Photograph 32).

Photograph 32. The Mn/DOT Specification 3U18 test sections exhibited both debonding and microcracks in some areas.

throughout those same areas. A couple of the slots had multiple cracks, creating loose chunks of patch material. Approximately 25% of the Mn/DOT Specification 3U18 test sections is performing well, with little to no debonding or microcracking present.

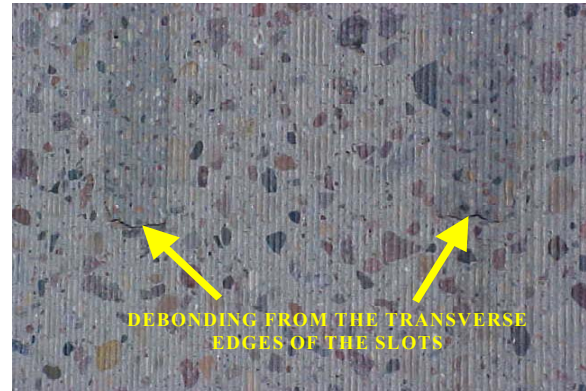
Debonding and microcracks were also observed in the Tamms Speed Crete 2028 test sections, located in the southbound driving lane of STH 13. The debonding in this section also occurred at the sidewalls or at the transverse ends of the slots (Photograph 33).

Some areas had a fair amount of debonding and microcracking, while other areas showed minimal distresses and appeared to be performing quite well. The microcracks that existed were consistently very fine and tight, as opposed to the Mn/DOT sections where it appeared that some of the cracks were more open. Cores taken from both the Tamms and the Mn/DOT 3U18 sections showed that the

Photograph 33. Debonding of the patch material from the transverse edge of the dowel bar slots was observed in the Tamms Speed Crete 2028 test sections.

microcracks don't extend far below the surface; thus, the surface microcracking is most likely due to evaporation of water from the surface. The severity and frequency of the debonding varied throughout the length of the Tamms test sections, but was typically less severe than the debonding that occurred in the Mn/DOT test sections. The area of the Tamms sections with the greatest amount of debonding and microcracking present was near the south end. It should be noted that construction of the Tamms Speed Crete 2028 test sections began at the north end, where calibration problems were prevalent. Calibration problems were resolved as construction continued to the south and the method for mixing the patch material was switched to a paddle mixer. Thus, even with a consistent mix, the Tamms Speed Crete 2028 is showing signs of distress in the form of microcracking and debonding.

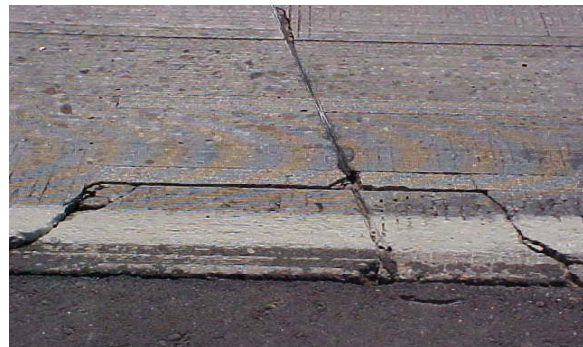
A section of pavement starting from the southern end of Test Section A and continuing north for about 550 feet had 12 joints with severe cracks that extended from the corners of the outside dowel bar slots to the outside edge of the pavement (Photograph 34). Approximately half of these joints only had the cracking on the upstream side of the joints (Photograph 35). These cracks are

Photograph 34. One year after construction, cracking was found extending from the corners of the outside dowel bar slot to the outside edge of pavement.

A closer observation of these cracks revealed that some of the cracks begin from the sidewall of the slot, while others begin from the corner of the slot. In most cases, the cracks seemed to start at the edge of noticeable debonding. At a couple of joints in the Tamms section, the cracks started from the sidewall of the second slot over from the outside edge, instead of the outside slot. At these locations, it was noticed that the material in the outside slots appear to be well bonded to the sidewalls, but some debonding was observed in the second slot, where the cracks started. One theory is that, since the cracks seem to propagate from a debonded sidewall or a debonded transverse end, the lack of bonding caused the pavement between the edge of the slot and the edge of the slab to become somewhat isolated from the remainder of the slab. When subjected to heavy loads, the isolated portion of the slab suffered fatigue failure due to accumulated stresses within the slab. Fatigue failure caused the isolated portion of the slab to crack, from the edge of the slot to the edge of the pavement. Another theory was that the jackhammering process created microcracks in the existing pavement, which eventually led to full depth cracks after repeated loadings. Cores taken, still in the early stages of corner cracking, revealed that the cracks initiated from the top of the pavement and propagated downward after repeated loadings. This revelation discredited the theory that the cracks were a result of the jackhammering process, since cracks of this nature would propagate from the bottom or side of the slots.

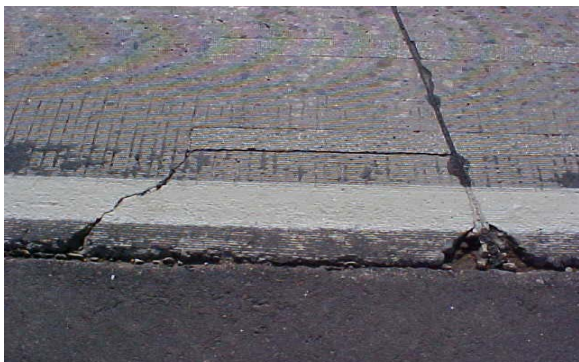
Photograph 35. Some of the slots with cracking in the outside edge of the pavement only had cracks on the upstream ends of the slots.

located in the Mn/DOT Specification 3U18 test section, where significant debonding of the material to the sidewalls was observed in the majority of slots.

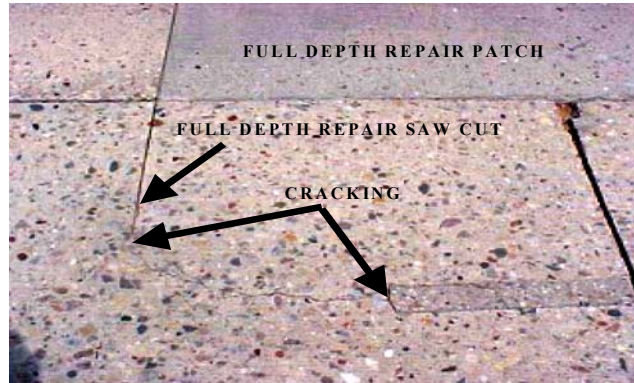
A similar type of cracking also occurred in several areas near pavement sections that had received full depth repair. The cracks extended from the corners of the dowel bar slots to the ends of the full depth repair saw cuts (Photograph 36).

Photograph 36. One year after construction, cracking was found extending from the corners of the outside dowel bar slot to the ends of the saw cuts from full depth repair sections.

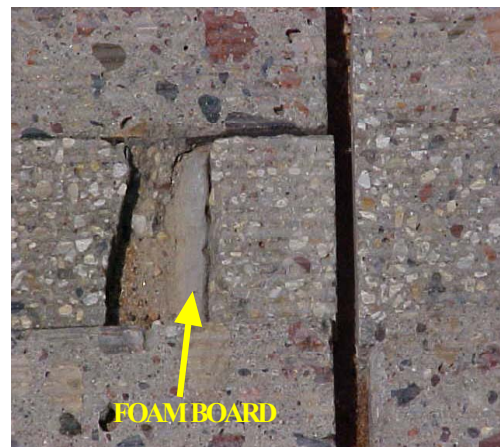
Thus far, the sealing or “unsealing” of joints has not affected the overall performance of the DBR or the patch materials. The joints in all of the test and control sections were performing well at the time of the field review. However, examples of poor workmanship of “finishing the joint” were observed in a few areas. Some locations did not have the foam board centered within the joint (Photograph 37).

Photograph 37. Cracking was present around the foam board at some joints where no care was taken to keep the foam board centered at the joint.

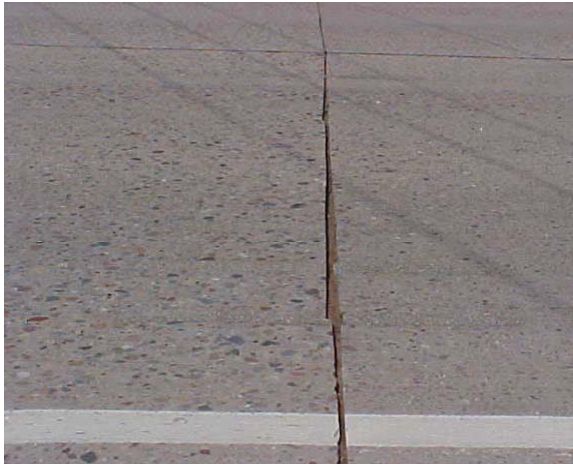
material is loose on both sides of the foam board. It is just a matter of time before the loose material becomes dislodged. Other locations had extremely messy saw cuts from restoring the joints (Photograph 38). In some locations, it was observed that the joint sealing was sloppy with sealant spilled on the adjacent pavement (Photograph 39).

Photograph 38. This photo shows the sloppy work that occurred at some of the joints when they were restored with a saw cut.

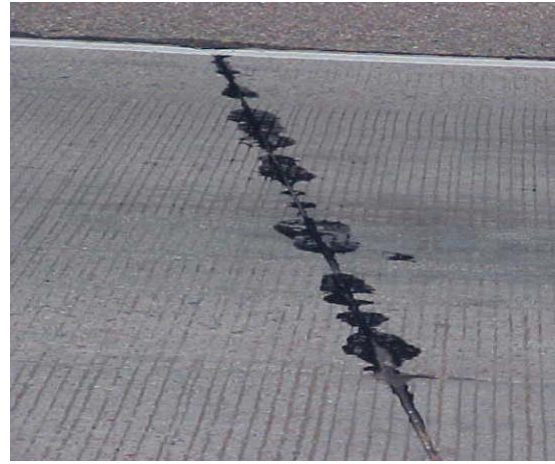
Photograph 39. Sealant was spilled onto the pavement when this joint was sealed.
